Annabelle's house

392 Arbourthorne Road, Sheffield S2 2FJ

A very general basic non-exhaustive overview of the above property concentrating on the main issues that require imminent attention. Lesser items are not mentioned, but if you require specific advice about any particular item (whether mentioned below or not) please feel free to contact me.

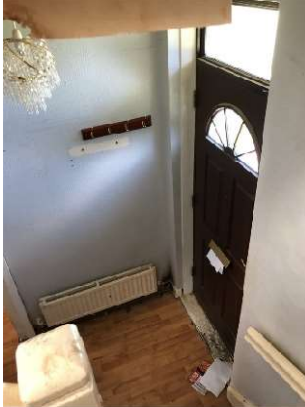
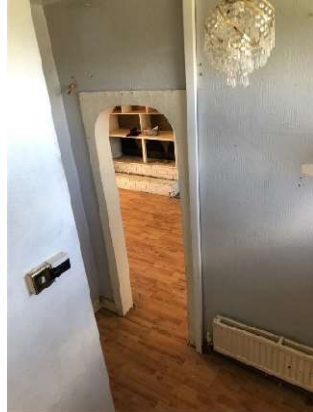
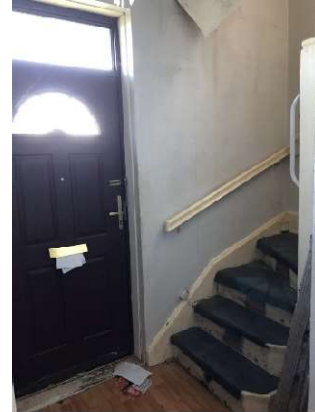
Entrance Hall

With stairs rising off to the first-floor landing and a useful under-stairs storage cupboard. Small central heating radiation could be increased in size. Provide and fix 30-minute fire resistant door between entrance hallway and Lounge.

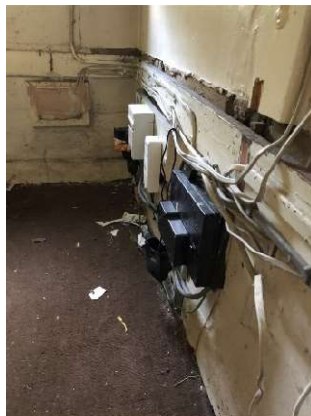
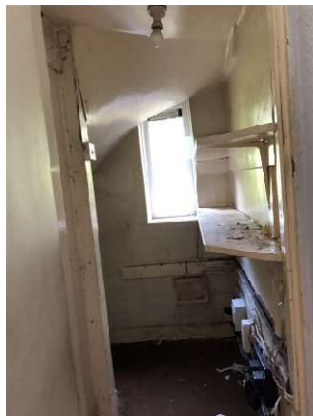
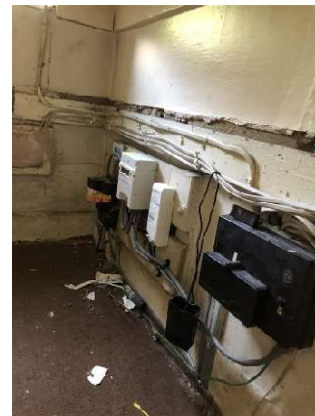
Under stairs storage cupboard

All electrical circuits need testing as a temporary safety stop-gap. 'Broken' fuse needs to be replaced as a temporary safety stop gap. Exterior circuits need to be removed. A new RDB circuit board will need to be installed in due course, but much of the existing wiring *may* be able to be retained. Provide and fix new 30-minute fire resistant door.

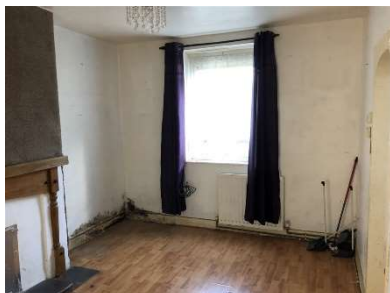
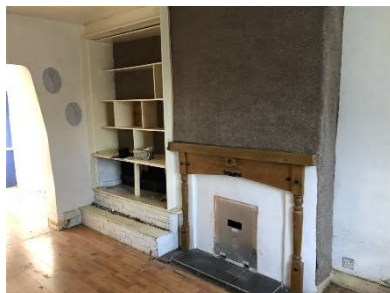
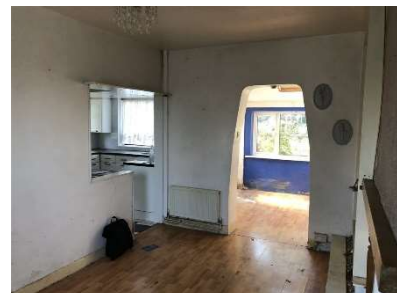
Lounge 15'4" x 10'4" (4.69m x 3.16m)

With a front facing double glazed window, a fire surround and a radiator. Chimney flue to be cleaned before use.

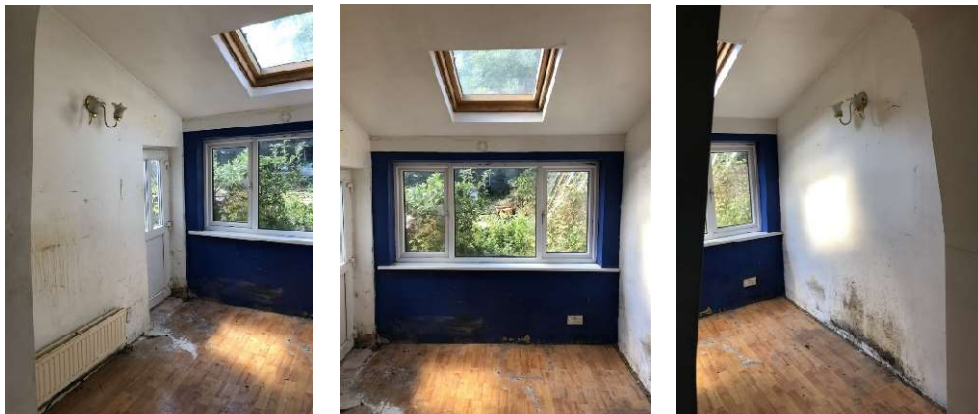
**Sun Room/Dining Room 7'10" x 9'0" (2.40m x 2.76m)**

A bright and sunny room with a side facing door leading out to the rear garden, a rear facing double glazed window, a Velux window to the ceiling and a radiator. Suggest radiator size is increased.

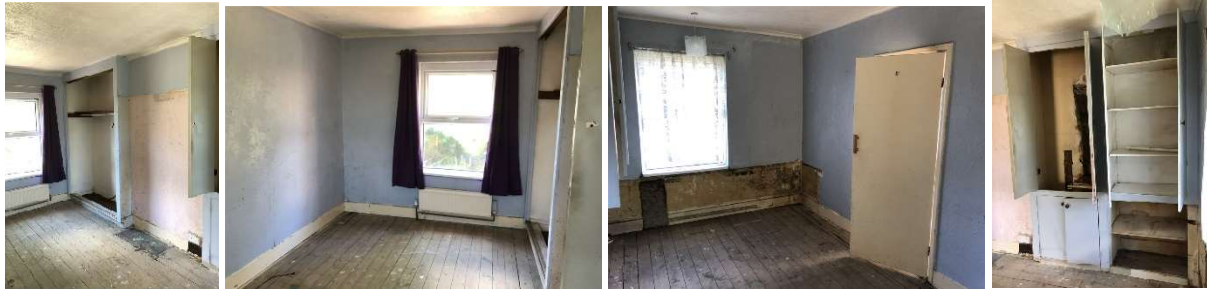
Bedroom One 15'4" x 9'2" (4.69m x 2.80m)

Having both a front and rear facing double glazed window, fitted wardrobes and cupboards and a radiator. Exterior rear windowsill to be made good with matching materials. Suggest radiator size is increased. Provide and fix new 30-minute fire resistant door.

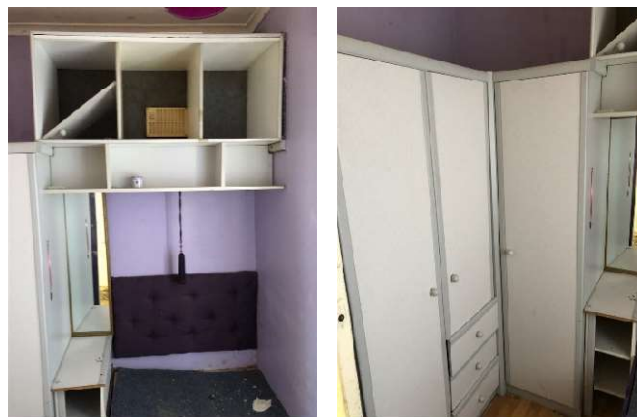
**Bedroom Two 8'5" x 7'1" (2.59m x 2.18m)**

Fitted with a range of fitted cupboards and a wardrobe, rear facing double glazed window and a radiator. Provide and fix new 30-minute fire resistant door.

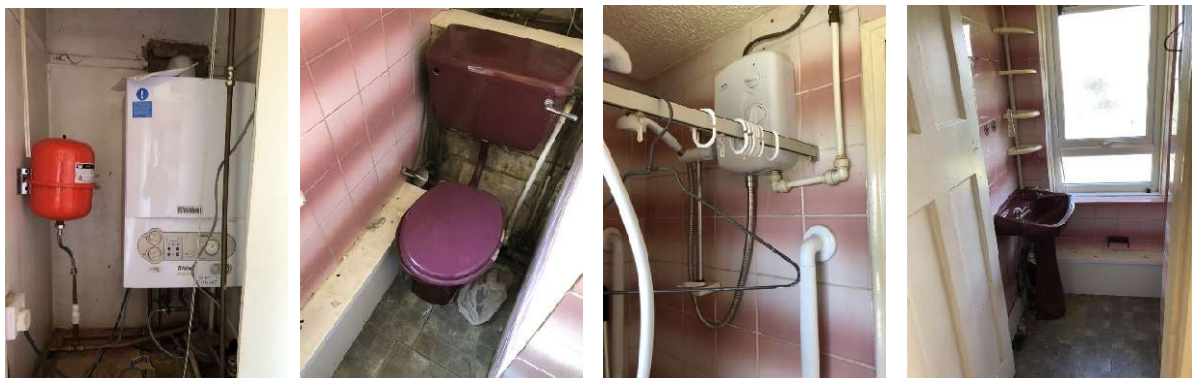
**Shower Room**

Fitted with a three-piece suite comprising of a shower cubicle with electric shower, wash hand basin, WC and a front facing double glazed window. All sanitary-ware to be replaced. Boiler to be serviced. Requirement for combustion air for boiler operation may necessitate new wall ventilator.

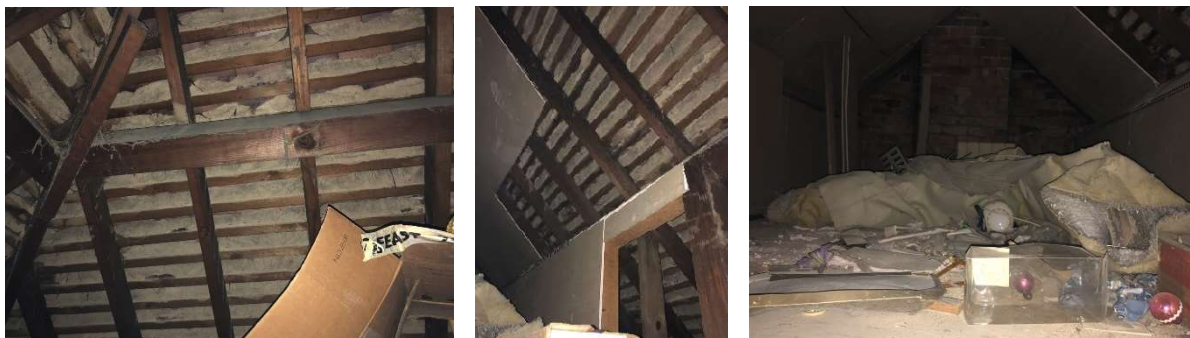
Roof space

Acceptable for 'temporary' access. Over-board floor and insulate roof internally, bearing in mind that rafters and tile battens need adequate ventilation. Insulate void between bedroom ceilings and underside of new floor covering.

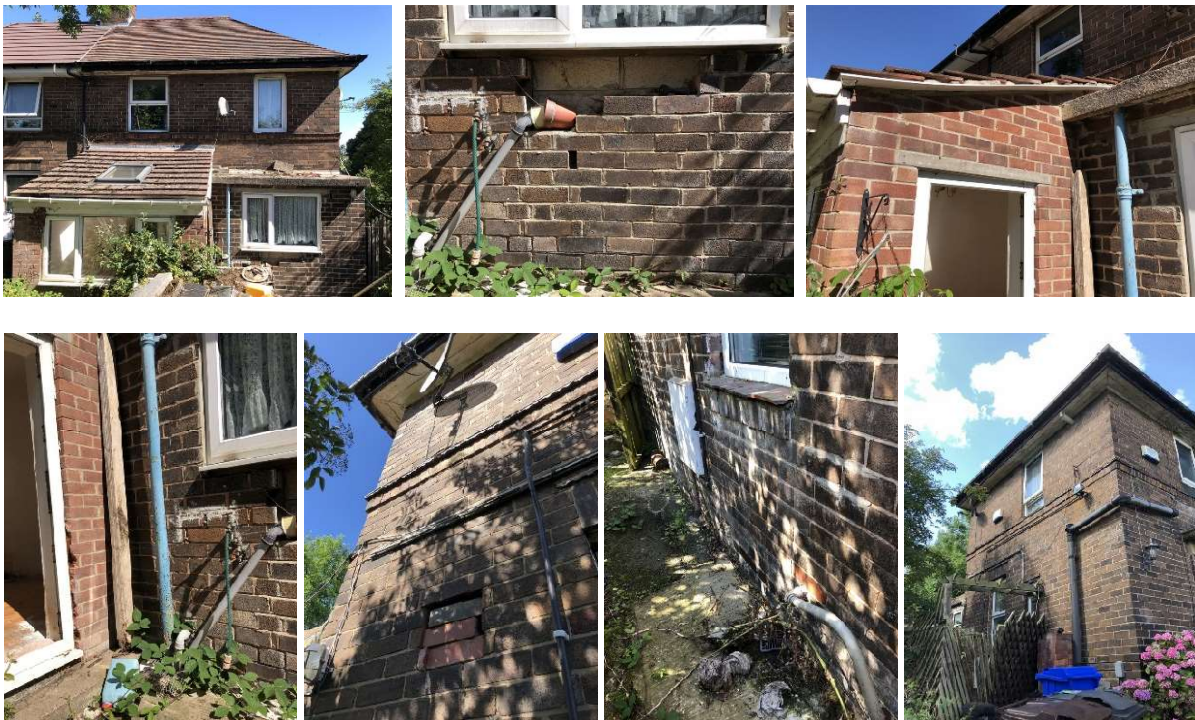
Outside

The main house roof appears to be OK and probably just needs some lime-based mortar pointing to the ridge tiles.

The shallow-pitch roof over the 'sun room' needs to be cleaned and the eaves re-pointed with lime-based mortar.

The flat roof over the kitchen needs to be insulated and finished with a liquid roof membrane (see Cure Roofing below). Outlet to rainwater pipe to be reformed.

Various items of masonry need to be made good and broken or missing brickwork replaced/made good. At least 1 terracotta ventilator needs to be replaced/reintroduced.

Upper gutters generally look OK but may need joints sealing. All to be cleaned out and painted externally.

Soffit (underside of roof below gutter) to be cleaned and painted.

All gullies and drains to be cleared. Move all debris and stored items away from outer face of all main house walls so that the walls can breathe.

Remove elder trees/shrubs (between house and garage) as these can become invasive. Be aware that neighbour's tree at the rear of the property might be laburnum, whose seeds are poisonous.

Lean-to structures at rear and side of garage to be carefully demolished.

Garage roof to be cleaned prior to sealing with Kingfisher (or similar approved) Asbestos Roof Sealer and Primer, which is a brush or spray applied, translucent solution formulated to bind, seal and consolidate the surface of old, friable asbestos roof sheets, encapsulating harmful dust and fibres ... see: <https://www.kingfisheruk.com/asbestos-roof-sealer-amp-primer-item-55ps#55ps> NB roof interior may also need to be sealed.

Boundary fence rust areas to be treated with rust inhibitor/converter prior to painting with rust-proof paint.
