Annabelle's house

392 Arbourthorne Road, Sheffield S2 2FJ

A very general basic non-exhaustive overview of the above property concentrating on the main issues that require imminent attention. Lesser items are not mentioned, but if you require specific advice about any particular item (whether mentioned below or not) please feel free to contact me.

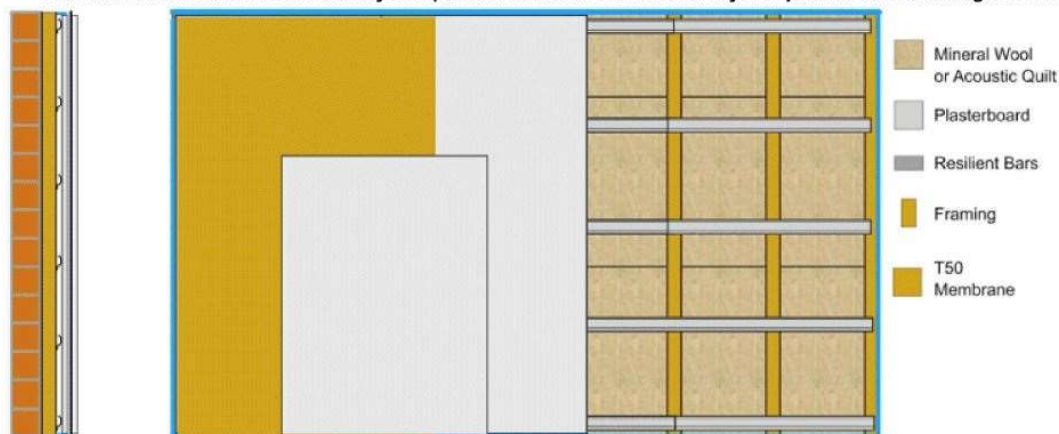
Consider sound insulation between your house and the immediate neighbours. For stud partitions that are new-build use acoustic mineral wool in the stud cavity. Or use the 2FTex quilt in the stud cavity as it has a layer of acoustic barrier sheet laminated in the middle of the product. Hang at least one side of the wall on resilient bars and use at least one layer of T50 or VL-65 acoustic membrane in between the plasterboard sheets. Isolate the perimeter of the framework with the RFT50 High Performance Resilient tape. Take care to seal the perimeter and joints with acoustic sealant and ensure you maintain resilient isolation from the framework using neoprene strips beneath the battens. Make the stud cavity as deep as possible or use independent frames for each side of the wall. Offset the second layer of plasterboard to reinforce the seams in the first (see diagram below)

This is for guidance only. If you are unsure about your DIY skills it may be better to contact an experienced builder.
Stick the T50 membrane to the first layer of plasterboard then add the final layer of plasterboard offset against the first.

Stick up the T60 membrane then add the final layer of plasterboard offset against the first
